City of Alexandria Storm Sewer Capacity Analysis (CASSCA)

Holmes Run Condition Assessment

PREPARED FOR: City of Alexandria, CH2M Hill
PREPARED BY: Baker
DATE: March 20, 2013 (Revised May 26, 2015)

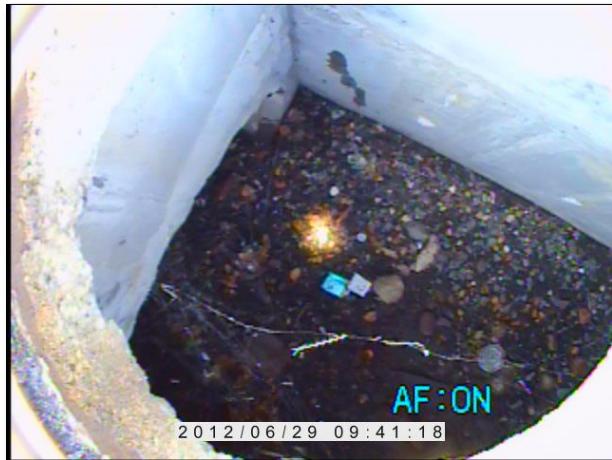
Observed defects were frequently associated with the chamber, chimney, and frame base seal components. Of the defects classified as major and extreme, most of them were still associated with the frame base seal, in addition to the manhole cover and channel. Cracks in the frame base seal 3/8" to 3/4" in size, for example, are considered major damage. Similarly, corrosion or spalling resulting in more than 50% material loss is considered extreme damage. Heavy debris (over 5 gallons in volume) in the channel is considered extreme. Figure 4 shows an example of major defects in the chamber.

**Figure 4. Settled Debris in Structure 009077IN
(Overall SCREAM Score = 50).**

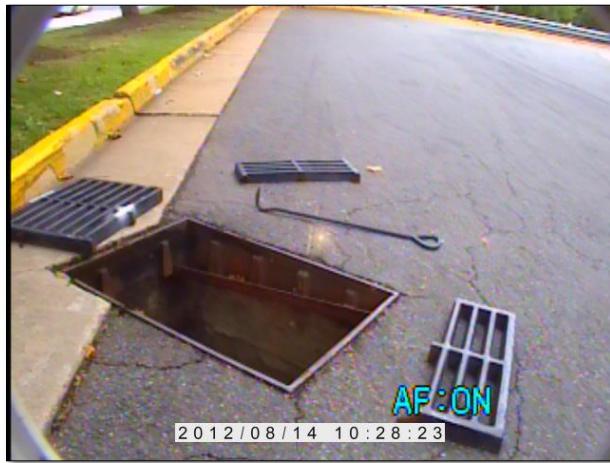
**Figure 5. Cracked Inlet Grate at Structure 004688IN
(Overall SCREAM Score = 99).**

Fourteen (14) of the structures inspected in Holmes Run watershed were identified in the major or extreme defect categories. The extreme defects were typically associated with the cover and frame base seal. Images of the fourteen (14) structures with overall SCREAM scores higher than 75 are shown in Figures 5 through 12. These issues can be remedied by adjustment of frame and cover or replacing the cover or inlet grate.

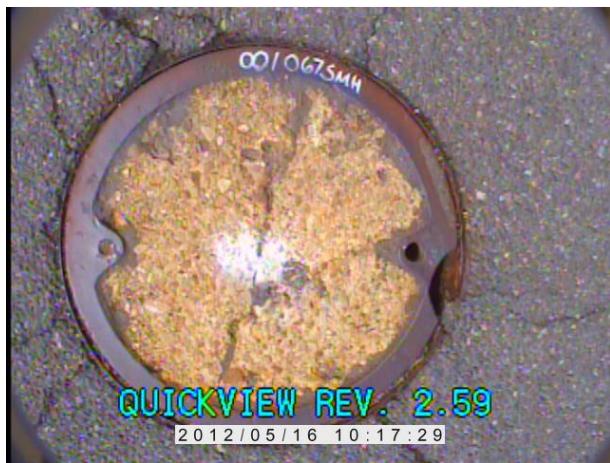
**Figure 6. Cracked Cover at Structure 001067SMH
(Overall SCREAM Score = 99).**

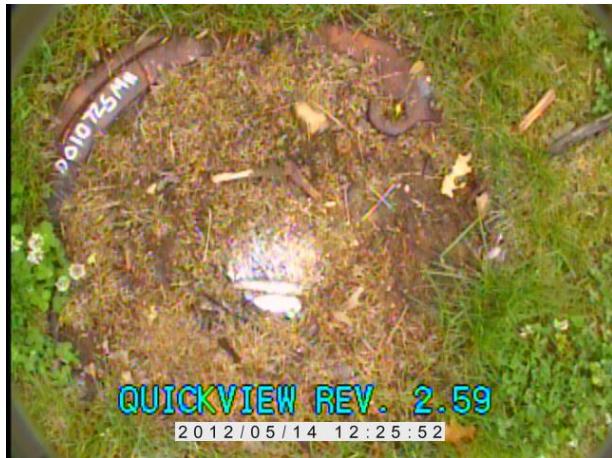
**Figure 7. Cracked Cover at Structure 001072SMH
(Overall SCREAM Score = 99).**

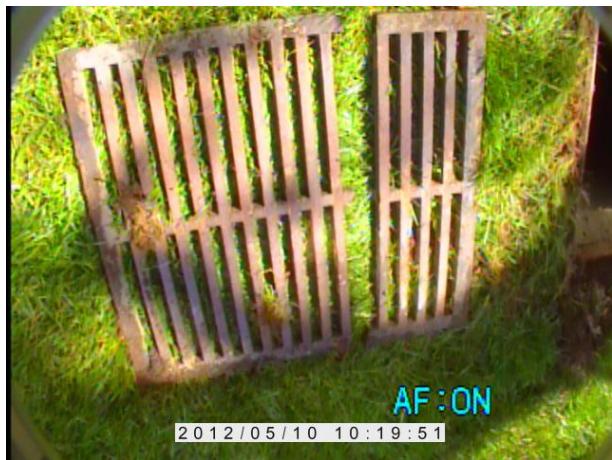
**Figure 8. Cracked Inlet Grate at Structure 002941IN
(Overall SCREAM Score = 99).**

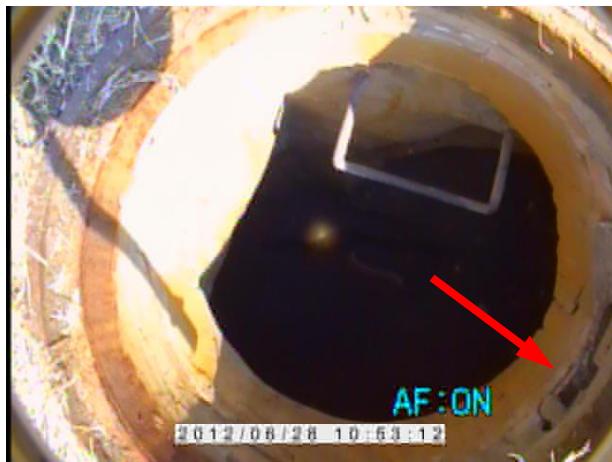
**Figure 9. Frame Base Seal Damage at Structure 000680SMH
(Overall SCREAM Score = 82).**

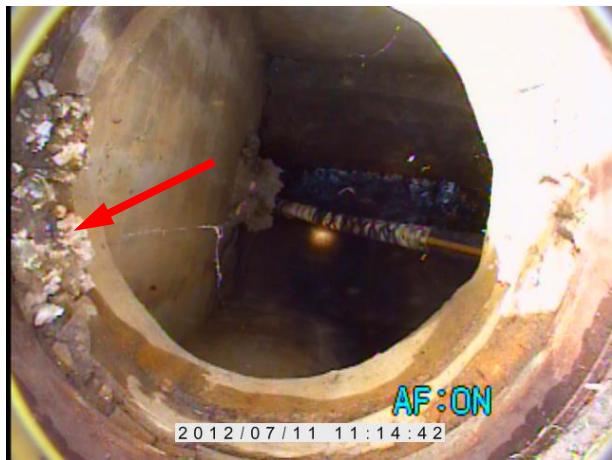
**Figure 10. Frame Base Seal Damage at Structure 000645SMH
(Overall SCREAM Score = 81).**

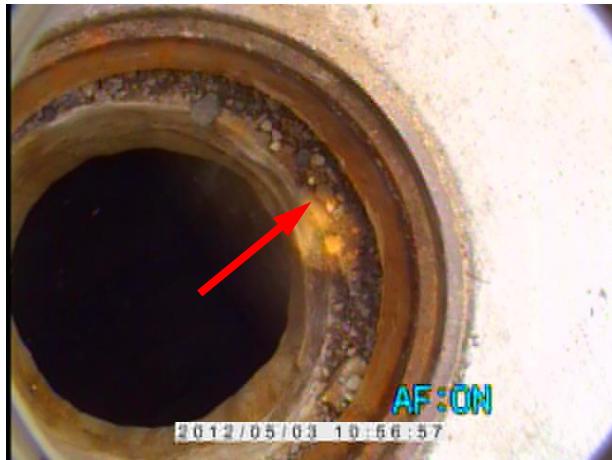
**Figure 11. Frame Base Seal Damage at Structure 000905SMH
(Overall SCREAM Score = 79).**

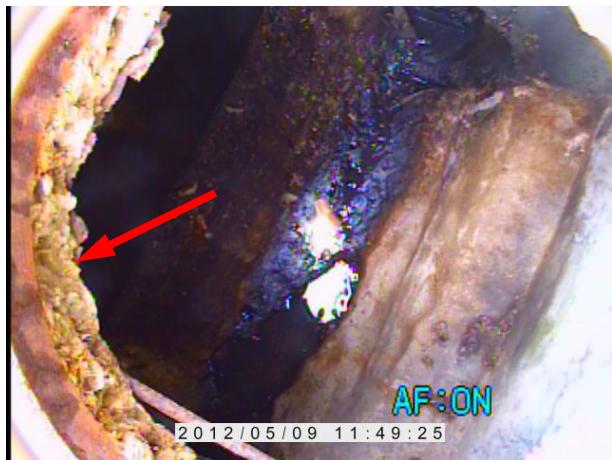
**Figure 12. Frame Base Seal Damage at Structure 003329IN
(Overall SCREAM Score = 76).**

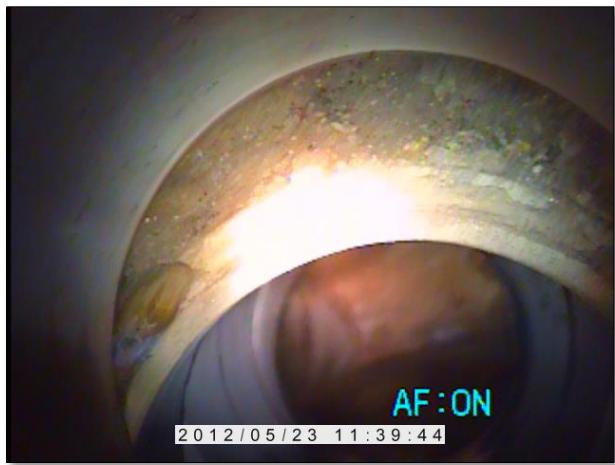
**Figure 15. Large Joint Offset in 24-in Storm Pipe between Structures 003857IN and 000274IO
(Overall SCREAM Score = 92).**

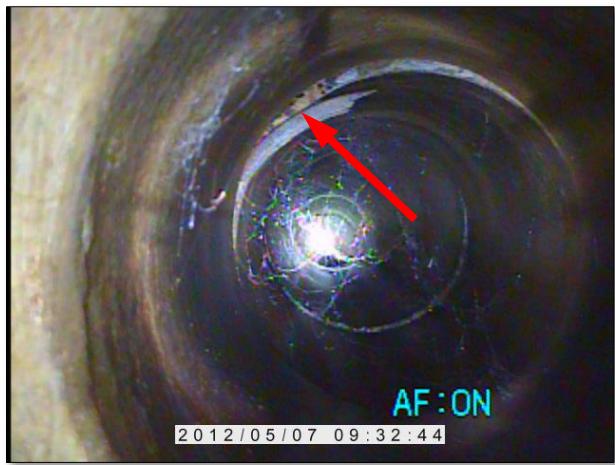
**Figure 16. Broken 15-in Storm Pipe between Structures 004778IN and 001527SMH
(Overall SCREAM Score = 53).**

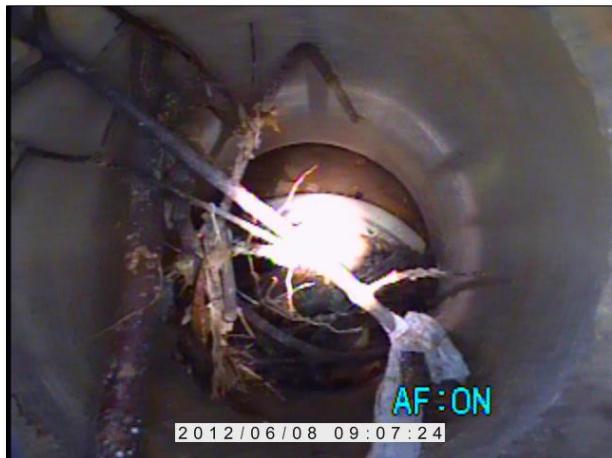
**Figure 17. Debris in 15-in Storm Pipe between Structures 002982IN and 000999SMH
(Overall SCREAM Score = 90).**

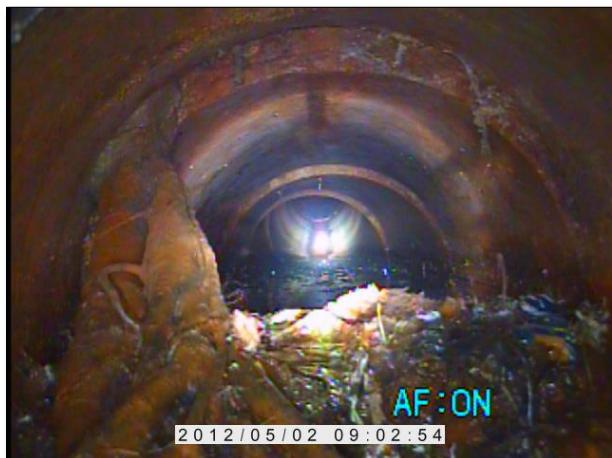
**Figure 18. Debris in 15-in Storm Pipe between Structures 002802IN and 002803IN
(Overall SCREAM Score = 100).**
